ASSESSMENT OF THE CHURCH STREET GRAVEYARD, MOBILE, ALABAMA

Research Contribution 566

Michael Trinkley
And
Debi Hacker

September 2015

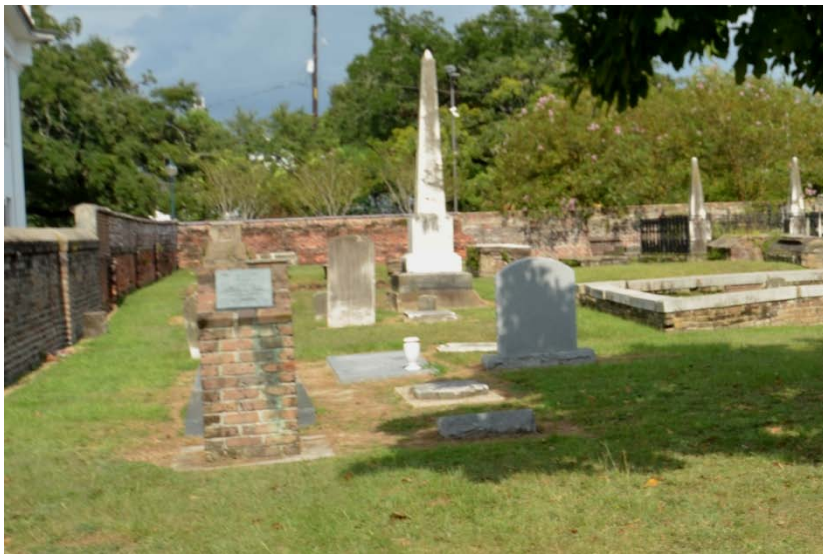
Figure 26. These new monuments are intrusive elements and disturb the scale and three-dimension aspect of the cemetery. New burials should not be allowed and new monuments should be carefully controlled.

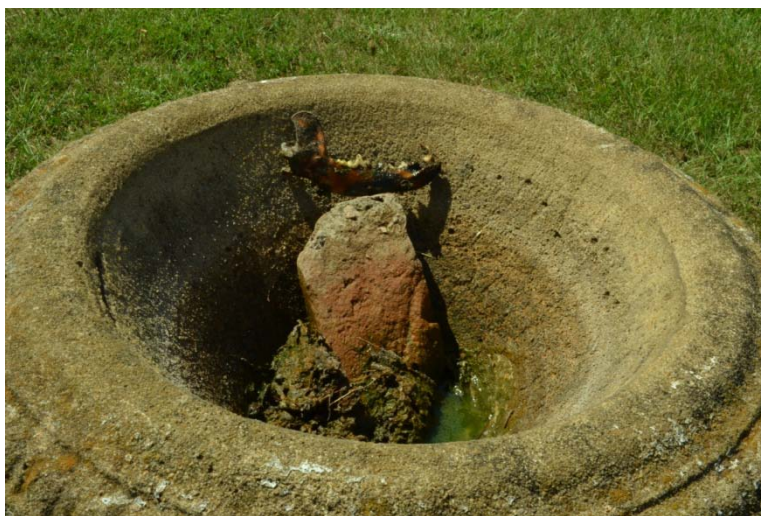
Figure 27. Example of an vase that is filled with sludge and trash.

of the upkeep. As a result, the urns often hold water, breed mosquitoes, collect trash, are turned upside down, or are just ignored. They are rarely repaired or replaced when broken. They are likely not used since most floral arrangements today come in their own plastic container, rendering the urns and vases redundant.

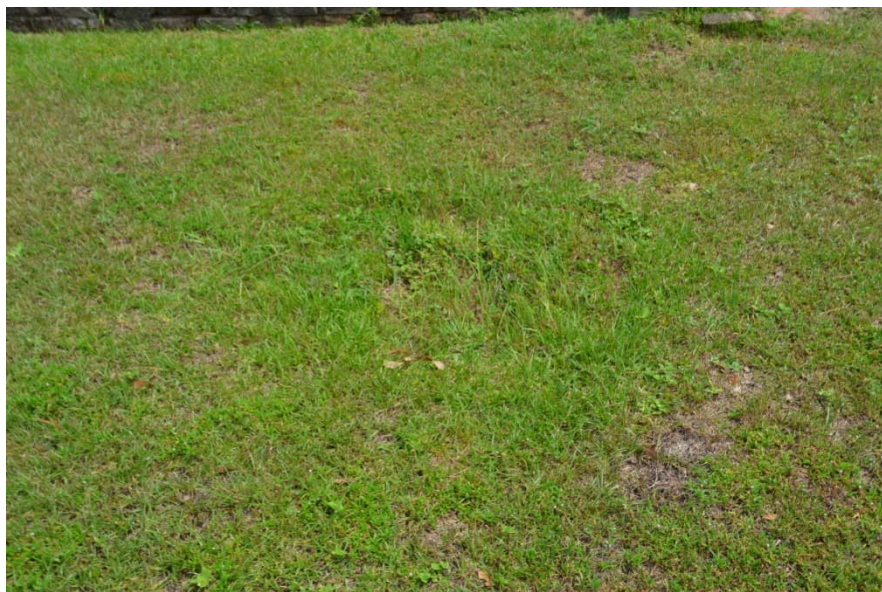
Figure 33. Sunken graves such as this blend into the landscape and pose a hazard to pedestrians.

The cemetery has a number of sinking or collapsing graves. These depressions mark grave locations and they should not be filled until such time that all depressions have been accurately mapped. After that is accomplished, backfilling them with clean sand and seeding will reduce mowing difficulty and improve general pedestrian safety.

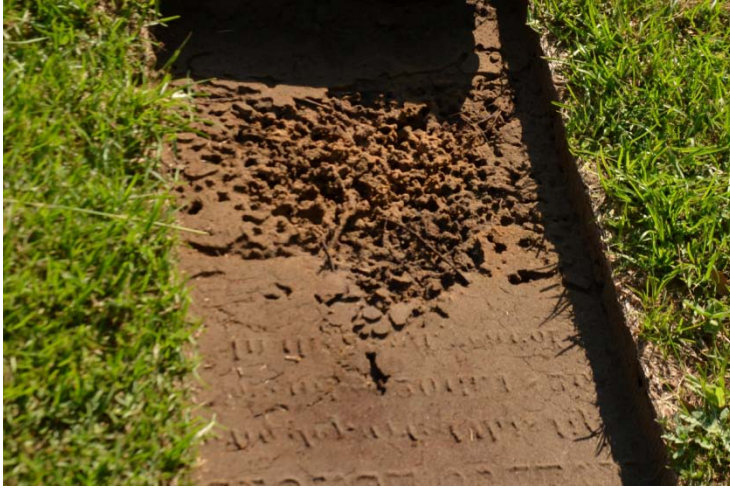
Figure 34. Fire ants under a collapsed monument.

After 10-14 days the Amdro should be used as an individual mound treatment on any mounds that continue to be a problem or that remain in high traffic areas.

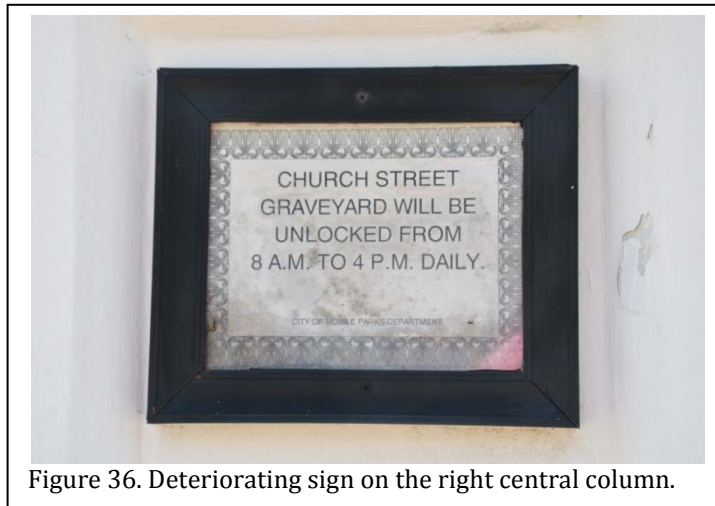
The primary regulatory signage is mounted on the far right column and is easily overlooked. The long paragraphs discourage attention to the regulations, which are not clearly spelled out. For example, the hours the cemetery is open are included, but apparently so often overlooked a second sign has been added to the right central column. This sign, apparently paper behind glass that is not weather tight, is growing mold and looks unattractive (Figure 36).

Figure 36. Deteriorating sign on the right central column.

If the City does not have a uniform style for signage, we like a classic black with rich gold lettering using a contemporary, but easily read typeface. The new sign should be located just inside the gates, beckoning visitors, but easily read even when the gates are closed. We do not

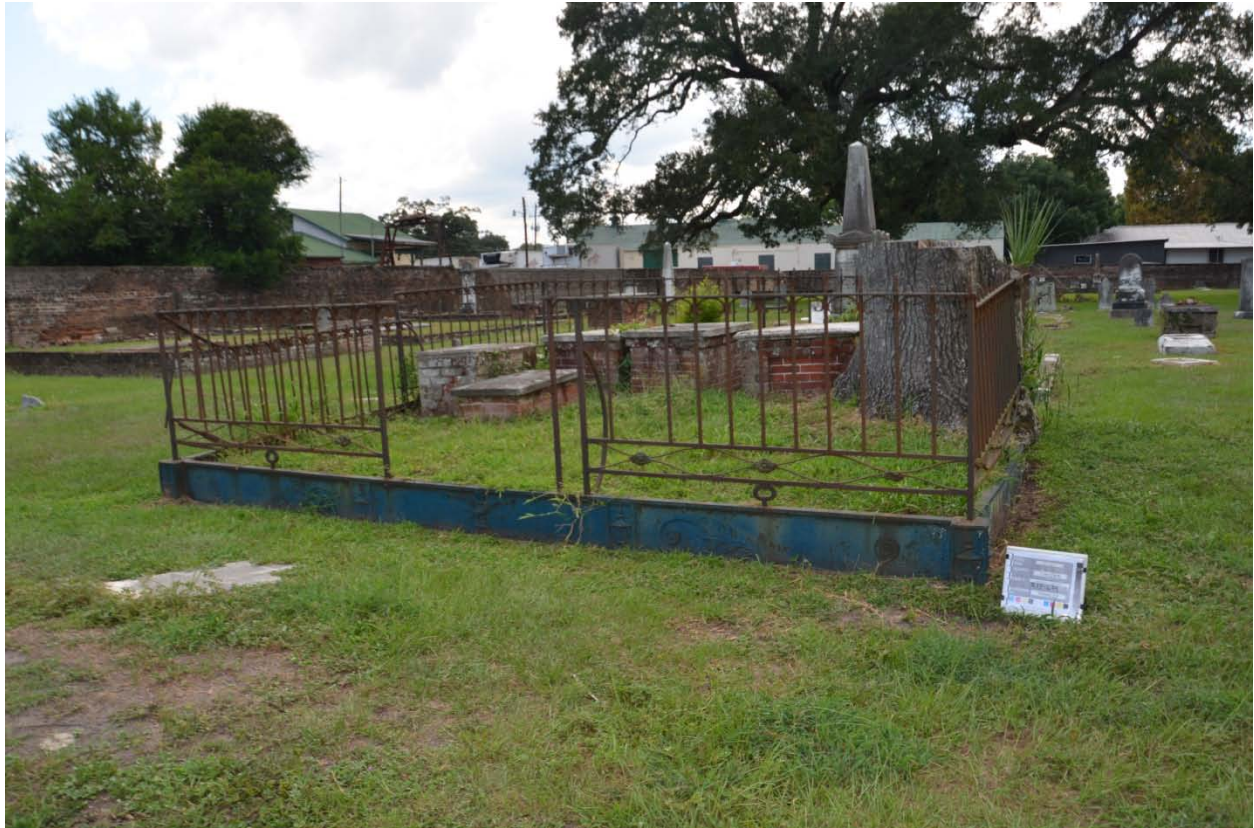
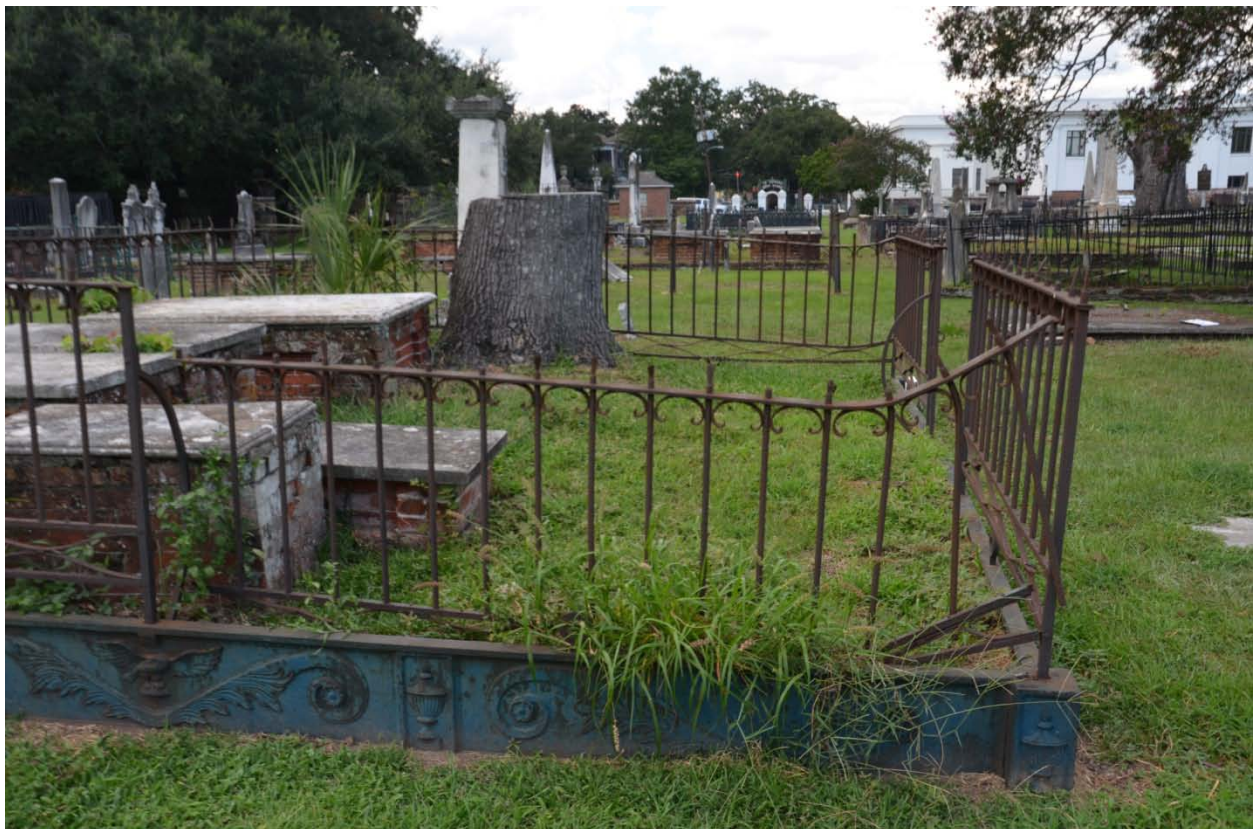
Previous Info	Historic Photos:
Existing Condition	Previous Observation(s) or Assessment(s): 1963, 1994
	Narrative: 1963, 8 iron posts, no fence; 1994, Greek revival, 3 uprights, floral base, no condition assessment
	Position: <input type="checkbox"/> fallen <input type="checkbox"/> tilted <input type="checkbox"/> unstable <input type="checkbox"/> unattached/loose <input checked="" type="checkbox"/> missing
	Elements Present: 2 of 4 corner posts 0 of 3 line posts 1 of 2 gate posts 0 of 1 gate(s)
	Condition of Baystays: <input checked="" type="checkbox"/> none present <input type="checkbox"/> good, stable <input type="checkbox"/> unattached <input type="checkbox"/> missing, unstable
	Deterioration: <input type="checkbox"/> broken <input type="checkbox"/> cracked <input checked="" type="checkbox"/> losses <input type="checkbox"/> corrosion <input type="checkbox"/> covered in soil <input checked="" type="checkbox"/> missing fragments <input checked="" type="checkbox"/> other: loss of 5 posts since 1963

Extent: <input checked="" type="checkbox"/> extensive >50% <input type="checkbox"/> partial 25-50% <input type="checkbox"/> minimal <25% <input type="checkbox"/> not applicable
	Failed/Old Treatments: <input type="checkbox"/> welds <input type="checkbox"/> adhesives/coatings <input type="checkbox"/> ferrous metals <input type="checkbox"/> wire/other attachment <input checked="" type="checkbox"/> paint, color: green <input type="checkbox"/> other:
	Foundations/Coping: <input type="checkbox"/> brick <input type="checkbox"/> concrete <input checked="" type="checkbox"/> granite <input type="checkbox"/> other:
	Foundation/Coping Condition: <input type="checkbox"/> brick loose, displaced <input type="checkbox"/> mortar damaged <input type="checkbox"/> coping displaced <input type="checkbox"/> coping missing <input type="checkbox"/> iron jacking <input type="checkbox"/> other:
Treatment Strategy	Position: <input type="checkbox"/> stabilize foundation <input type="checkbox"/> reset line posts <input type="checkbox"/> reset corner posts <input type="checkbox"/> reset/realign gate posts/gate

Foundation/Coping: <input type="checkbox"/> point wall <input type="checkbox"/> rebuild wall <input type="checkbox"/> reset coping <input type="checkbox"/> repair iron jacking location <input type="checkbox"/> other:
	Treatment: <input type="checkbox"/> remove soil from fence bottom rails <input type="checkbox"/> re-attach fence sections <input type="checkbox"/> backstays <input type="checkbox"/> straighten sections <input checked="" type="checkbox"/> caulk prior to painting <input type="checkbox"/> other:
	Needed Replacement Elements:
	Other Detailed Observations:
	Paint: <input type="checkbox"/> test for lead <input type="checkbox"/> air abrasion <input checked="" type="checkbox"/> hand tools <input type="checkbox"/> rust converter primer <input checked="" type="checkbox"/> primer <input checked="" type="checkbox"/> top coat alkyd flat paint (two coats) <input type="checkbox"/> other:
Recast/Replace: <input type="checkbox"/> describe:

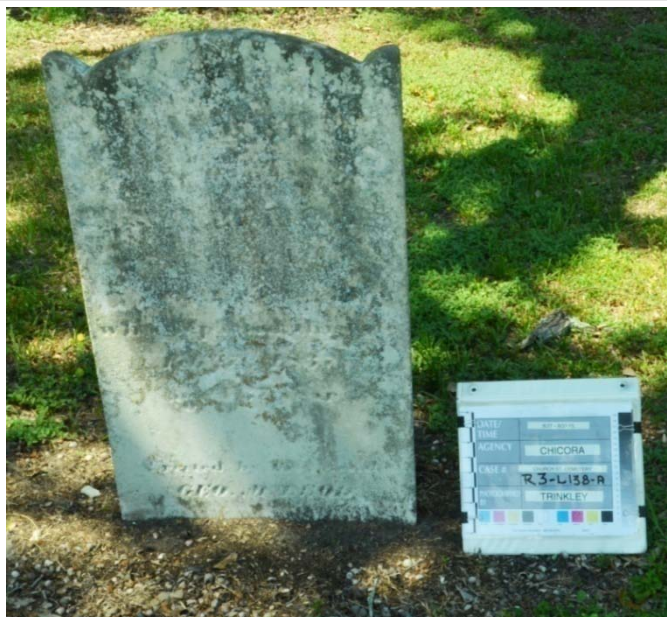
Row: 4

Position: ☐ fallen ☐ tilted ☐ unstable ☒ unattached/loose ☐ missing

Deterioration: ☒ broken ☐ cracked ☐ losses ☐ flaking/sugaring ☐ ferrous pins
☐ brass pins ☐ delamination/detachment ☐ spalling ☒ missing fragments
☐ other:

Soiling: ☒ biological ☐ staining ☐ efflorescence ☐ other:

Treatment: ☐ core drill ☒ drill and pin ☐ simple adhesive repair ☐ injection grout ☐ set bricks
☐ mortar ☐ repoint ☒ infill ☐ other:

Cost: \$1,200

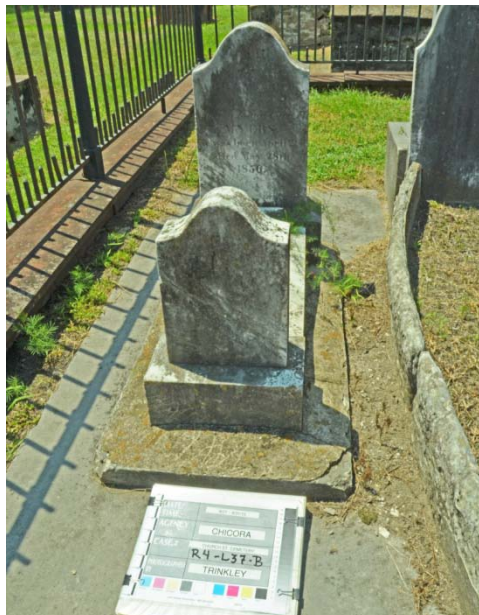
Row: 4

Position: ☐ fallen ☒ tilted ☒ unstable ☒ unattached/loose ☐ missing

Deterioration: ☐ broken ☐ cracked ☐ losses ☐ flaking/sugaring ☐ ferrous pins
☐ brass pins ☐ delamination/detachment ☐ spalling ☐ missing fragments
☒ other: set on base of bricks and bricks deteriorating

Soiling: ☒ biological ☐ staining ☐ efflorescence ☐ other:

Position: ☒ reset/level in ground ☐ use existing base ☐ construct new base ☐ resquare
☐ new base required ☐ stabilize foundation ☒ reset with NHL ☐ reset with compound
☒ other: remove bricks and establish good foundation

Treatment: ☒ core drill ☒ drill and pin ☐ simple adhesive repair ☐ injection grout ☐ set bricks
☐ mortar ☐ repoint ☐ infill ☐ other:

Cost: \$1,800

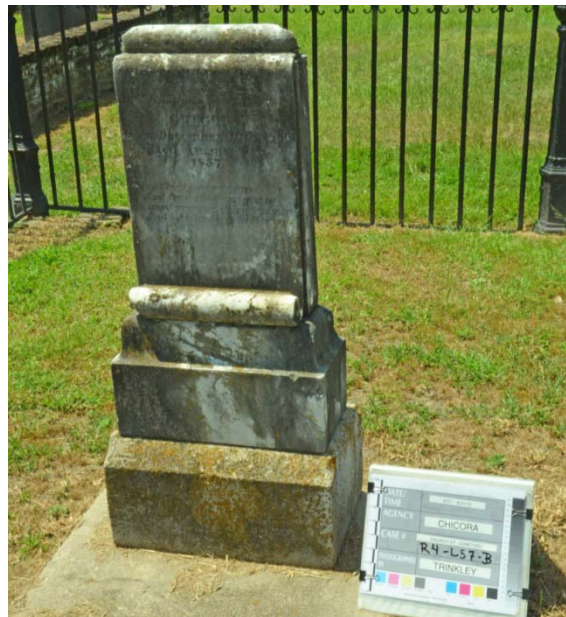
Row: 4

Position: ☒ fallen ☒ tilted ☒ unstable ☐ unattached/loose ☐ missing

Deterioration: ☒ broken ☐ cracked ☐ losses ☐ flaking/sugaring ☐ ferrous pins
☐ brass pins ☐ delamination/detachment ☐ spalling ☐ missing fragments
☐ other:

Failed/Old Treatments: ☐ metal ☐ adhesives/coatings ☐ mortar ☒ other: OPC

Soiling: ☒ biological ☐ staining ☐ efflorescence ☐ other:

Position: ☒ reset/level in ground ☐ use existing base ☐ construct new base ☐ resquare
☐ new base required ☐ stabilize foundation ☐ reset with NHL ☐ reset with compound
☒ other: if base can't be found, reset in new OPC socket

Failed Treatments: ☐ drill/grind ☒ hand tools ☐ solvents ☐ other:

Treatment: ☐ core drill ☒ drill and pin ☐ simple adhesive repair ☐ injection grout ☐ set bricks
☐ mortar ☐ repoint ☒ infill ☐ other:

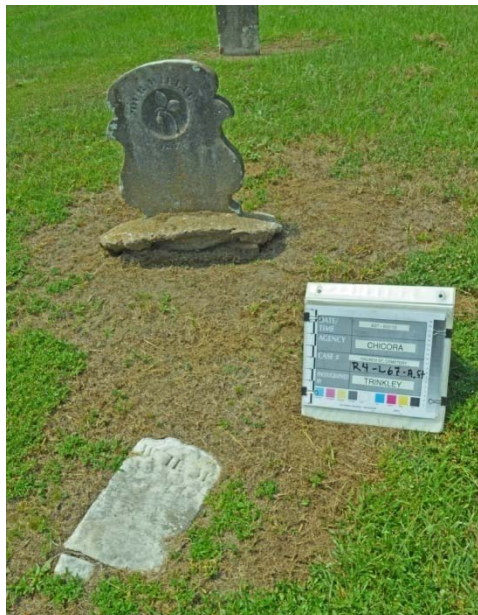
Row: 4

Position: ☒ fallen ☐ tilted ☐ unstable ☐ unattached/loose ☐ missing

Deterioration: ☒ broken ☐ cracked ☐ losses ☒ flaking/sugaring ☐ ferrous pins
☐ brass pins ☐ delamination/detachment ☐ spalling ☐ missing fragments
☐ other:

Position: ☒ reset/level in ground ☐ use existing base ☐ construct new base ☐ resquare
☐ new base required ☐ stabilize foundation ☐ reset with NHL ☐ reset with compound
☐ other:

Treatment: ☐ core drill ☒ drill and pin ☐ simple adhesive repair ☐ injection grout ☐ set bricks
☐ mortar ☐ repoint ☐ infill ☒ other: if stone not suitable for drilling, reset in new OPC socket

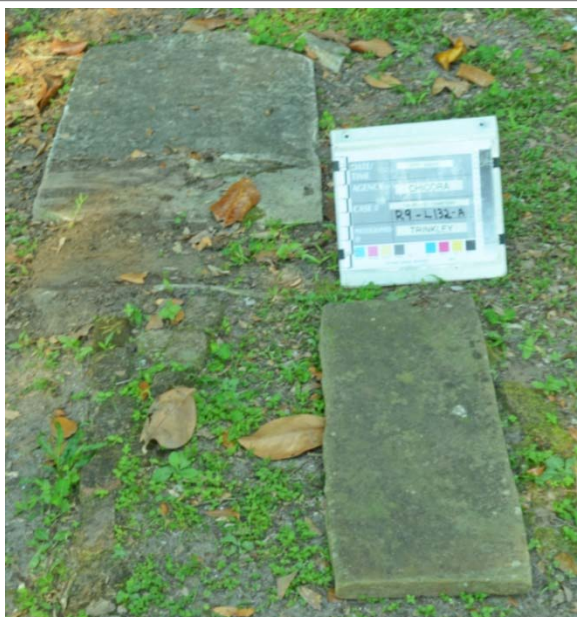
Row: 10

Position: ☒ fallen ☐ tilted ☐ unstable ☐ unattached/loose ☐ missing

Legibility: ☐ sharp, tooling evident ☒ clear, but worn ☐ partially discernable ☐ not discernable

Deterioration: ☒ broken ☐ cracked ☐ losses ☐ flaking/sugaring ☐ ferrous pins
☐ brass pins ☐ delamination/detachment ☐ spalling ☐ missing fragments
☒ other: mower damage

Soiling: ☒ biological ☐ staining ☐ efflorescence ☐ other:

Position: ☐ reset/level in ground ☐ use existing base ☒ construct new base ☐ resquare
☐ new base required ☐ stabilize foundation ☐ reset with NHL ☐ reset with compound
☐ other:

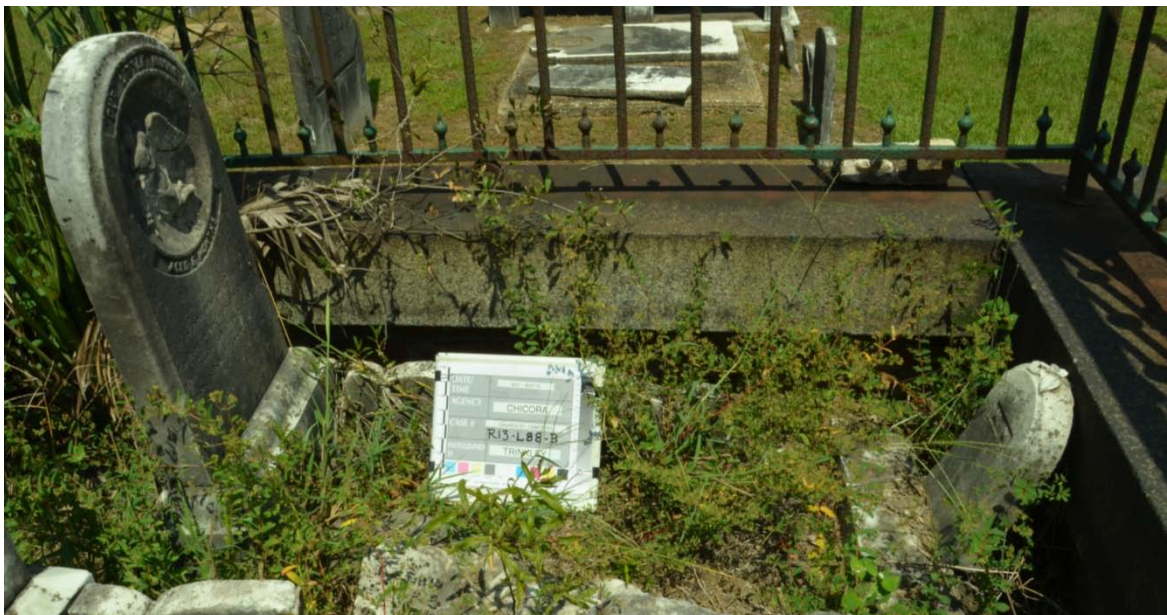
Row: 13

Position: ☒ fallen ☒ tilted ☐ unstable ☐ unattached/loose ☐ missing

Deterioration: ☒ broken ☐ cracked ☐ losses ☐ flaking/sugaring ☐ ferrous pins
☐ brass pins ☐ delamination/detachment ☐ spalling ☐ missing fragments
☐ other:

Soiling: ☒ biological ☐ staining ☐ efflorescence ☐ other:

Position: ☒ reset/level in ground ☐ use existing base ☐ construct new base ☐ resquare
☐ new base required ☐ stabilize foundation ☐ reset with NHL ☐ reset with compound
☐ other:

Treatment: ☐ core drill ☒ drill and pin ☐ simple adhesive repair ☐ injection grout ☐ set bricks
☐ mortar ☐ repoint ☒ infill ☐ other:

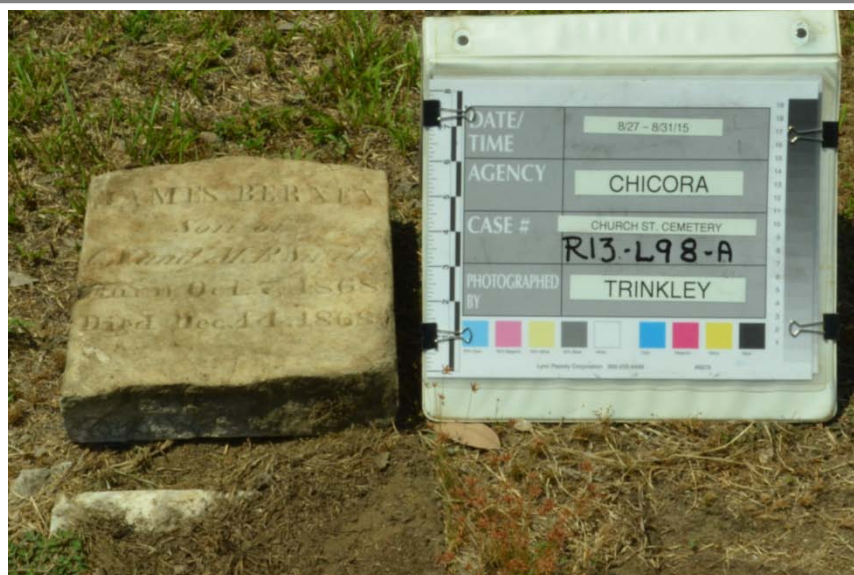
Row: 13

Position: ☒ fallen ☐ tilted ☐ unstable ☐ unattached/loose ☐ missing

Soiling: ☒ biological ☐ staining ☐ efflorescence ☐ other:

Position: ☒ reset/level in ground ☐ use existing base ☐ construct new base ☐ resquare
☐ new base required ☐ stabilize foundation ☐ reset with NHL ☐ reset with compound
☐ other:

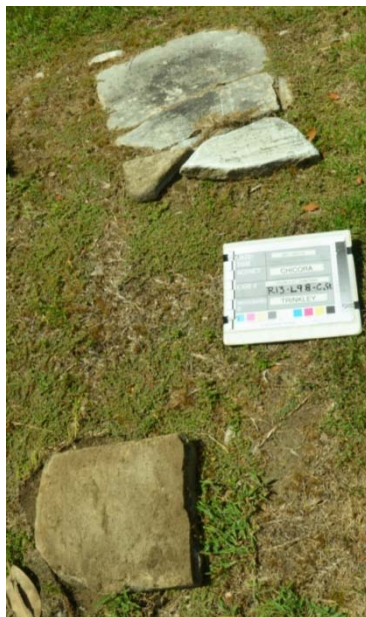
Row: 13

Position: ☒ fallen ☐ tilted ☐ unstable ☐ unattached/loose ☐ missing

Deterioration: ☒ broken ☐ cracked ☐ losses ☐ flaking/sugaring ☐ ferrous pins
☐ brass pins ☐ delamination/detachment ☐ spalling ☐ missing fragments
☐ other:

Soiling: ☒ biological ☐ staining ☐ efflorescence ☐ other:

Position: ☒ reset/level ☐ in ground ☐ use existing base ☐ construct new base ☐ resquare
☐ new base required ☐ stabilize foundation ☐ reset with NHL ☐ reset with compound
☐ other:

Treatment: ☐ core drill ☒ drill and pin ☐ simple adhesive repair ☐ injection grout ☐ set bricks
☐ mortar ☐ repoint ☒ infill ☐ other:

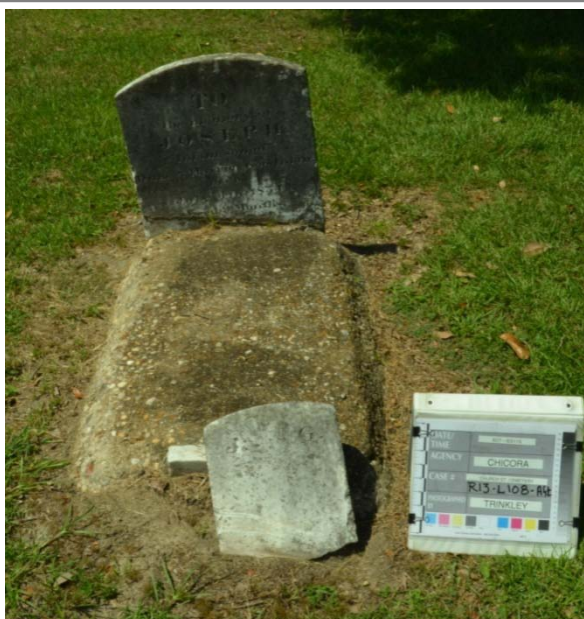
Row: 13

Position: ☒ fallen ☐ tilted ☐ unstable ☒ unattached/loose ☐ missing

Deterioration: ☒ broken ☐ cracked ☐ losses ☐ flaking/sugaring ☐ ferrous pins
☐ brass pins ☐ delamination/detachment ☐ spalling ☐ missing fragments
☒ other: 1 or more fragments set behind

Soiling: ☒ biological ☐ staining ☐ efflorescence ☐ other:

Position: ☒ reset/level in ground ☐ use existing base ☐ construct new base ☐ resquare
☐ new base required ☐ stabilize foundation ☐ reset with NHL ☐ reset with compound
☒ other: if base can't be found, reset in new OPC socket

Treatment: ☐ core drill ☒ drill and pin ☐ simple adhesive repair ☐ injection grout ☐ set bricks
☐ mortar ☐ repoint ☒ infill ☐ other:

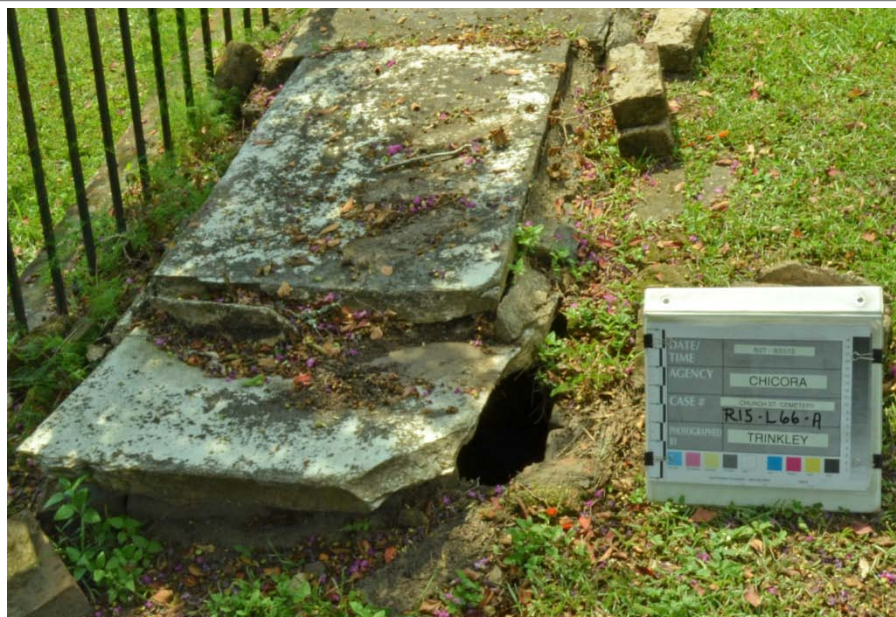
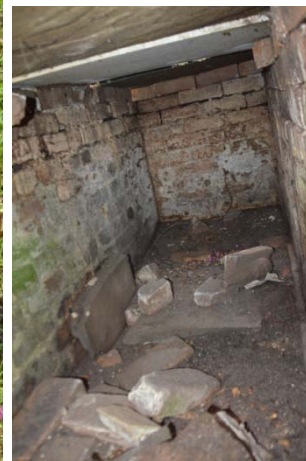
Row: 15

Position: ☒ fallen ☐ tilted ☐ unstable ☐ unattached/loose ☐ missing

Legibility: ☐ sharp, tooling evident ☒ clear, but worn ☐ partially discernable ☐ not discernable

Deterioration: ☐ broken ☐ cracked ☐ losses ☐ flaking/sugaring ☐ ferrous pins
☐ brass pins ☐ delamination/detachment ☐ spalling ☒ missing fragments
☐ other:

Soiling: ☒ biological ☐ staining ☐ efflorescence ☐ other:

Position: ☐ reset/level in ground ☒ use existing base ☐ construct new base ☐ resquare
☐ new base required ☐ stabilize foundation ☒ reset with NHL ☐ reset with compound
☐ other:

Treatment: ☐ core drill ☐ drill and pin ☐ simple adhesive repair ☐ injection grout ☐ set bricks
☐ mortar ☐ repoint ☐ infill ☐ other:

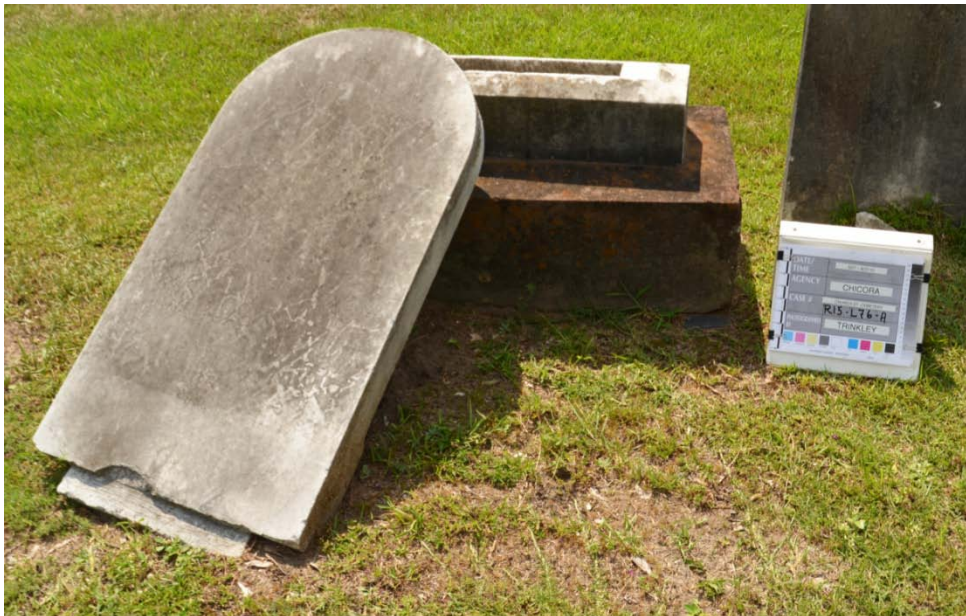
Row: 15

Position: ☒ fallen ☐ tilted ☐ unstable ☐ unattached/loose ☐ missing

Legibility: ☐ sharp, tooling evident ☒ clear, but worn ☐ partially discernable ☐ not discernable

Deterioration: ☒ broken ☐ cracked ☐ losses ☐ flaking/sugaring ☐ ferrous pins
☐ brass pins ☐ delamination/detachment ☐ spalling ☒ missing fragments
☐ other:

Soiling: ☒ biological ☒ staining ☐ efflorescence ☐ other:

Position: ☐ reset/level in ground ☐ use existing base ☐ construct new base ☐ resquare
☐ new base required ☐ stabilize foundation ☐ reset with NHL ☐ reset with compound
☒ other: if base can't be found, reset in new OPC socket

Treatment: ☐ core drill ☐ drill and pin ☒ simple adhesive repair ☐ injection grout ☐ set bricks
☐ mortar ☐ repoint ☐ infill ☐ other:

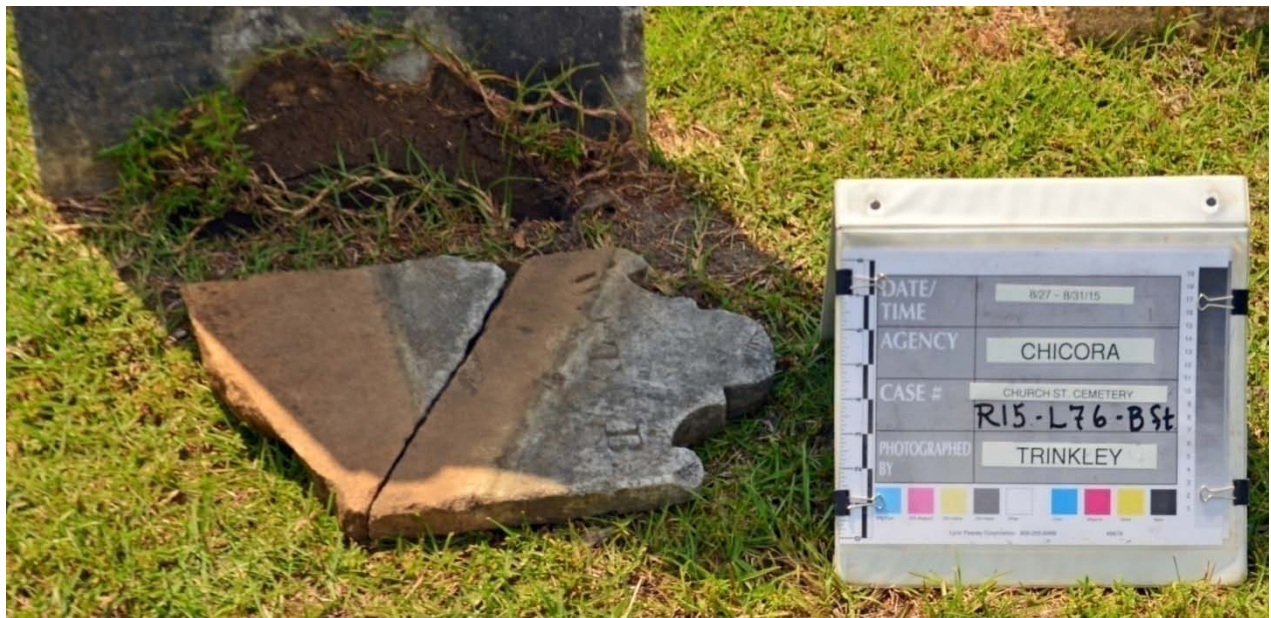
Row: 15

Position: ☒ fallen ☐ tilted ☐ unstable ☐ unattached/loose ☐ missing

Legibility: ☐ sharp, tooling evident ☒ clear, but worn ☐ partially discernable ☐ not discernable

Deterioration: ☒ broken ☐ cracked ☐ losses ☐ flaking/sugaring ☐ ferrous pins
☐ brass pins ☐ delamination/detachment ☐ spalling ☐ missing fragments
☐ other:

Soiling: ☒ biological ☐ staining ☐ efflorescence ☐ other:

Position: ☐ reset/level in ground ☐ use existing base ☐ construct new base ☐ resquare
☐ new base required ☐ stabilize foundation ☐ reset with NHL ☐ reset with compound
☒ other: if base can't be found, reset in new OPC socket

Treatment: ☐ core drill ☐ drill and pin ☒ simple adhesive repair ☐ injection grout ☐ set bricks
☐ mortar ☐ repoint ☐ infill ☐ other:

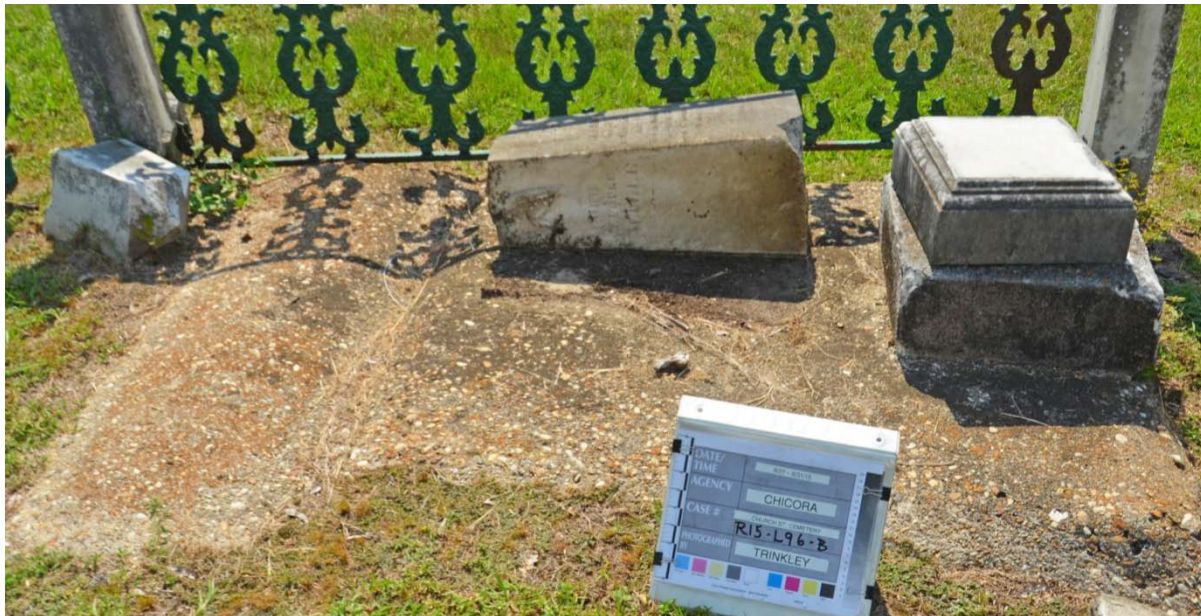
Row: 15

Position: ☒ fallen ☐ tilted ☐ unstable ☐ unattached/loose ☐ missing

Legibility: ☐ sharp, tooling evident ☒ clear, but worn ☐ partially discernable ☐ not discernable

Deterioration: ☐ broken ☐ cracked ☐ losses ☐ flaking/sugaring ☐ ferrous pins
☐ brass pins ☐ delamination/detachment ☐ spalling ☐ missing fragments
☒ other: tablet has been laid as a ledger; should be set upright for long-term preservation; mower damage

Soiling: ☒ biological ☐ staining ☐ efflorescence ☐ other:

Position: ☒ reset/level in ground ☐ use existing base ☐ construct new base ☐ resquare
☐ new base required ☐ stabilize foundation ☐ reset with NHL ☐ reset with compound
☐ other:

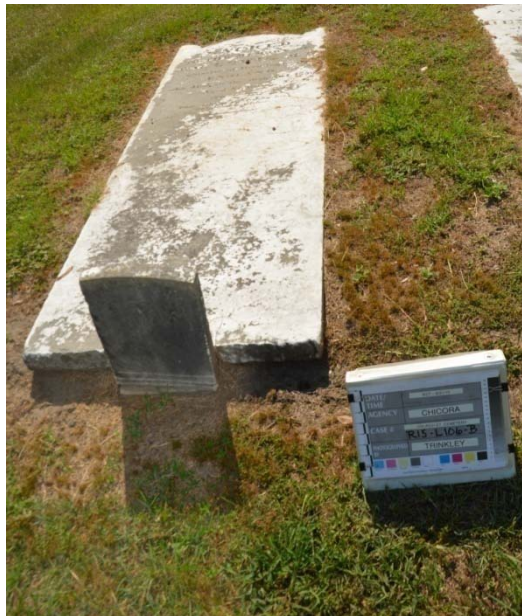
Row: 15

Position: ☒ fallen ☐ tilted ☐ unstable ☐ unattached/loose ☐ missing

Legibility: ☐ sharp, tooling evident ☒ clear, but worn ☐ partially discernable ☐ not discernable

Deterioration: ☐ broken ☐ cracked ☐ losses ☐ flaking/sugaring ☐ ferrous pins
☐ brass pins ☐ delamination/detachment ☐ spalling ☐ missing fragments
☒ other: tablet has been laid as a ledger; should be set upright for long-term preservation; mower damage

Soiling: ☒ biological ☐ staining ☐ efflorescence ☐ other:

Position: ☒ reset/level in ground ☐ use existing base ☐ construct new base ☐ resquare
☐ new base required ☐ stabilize foundation ☐ reset with NHL ☐ reset with compound
☐ other:

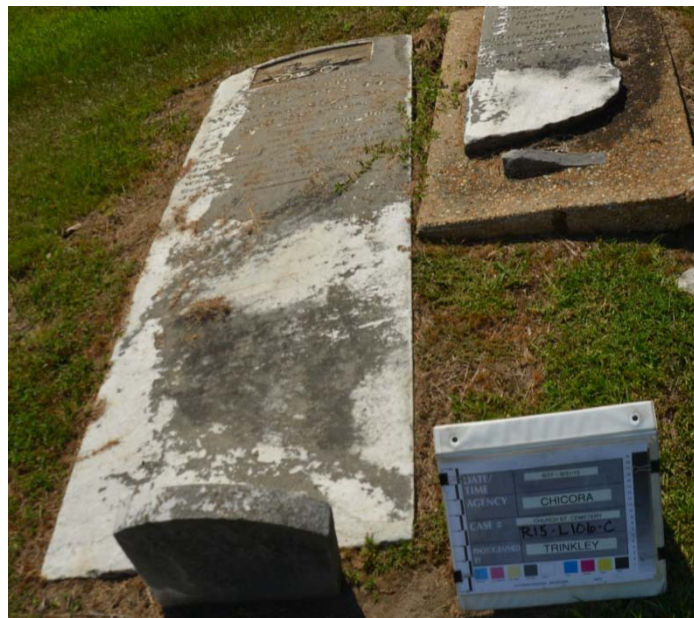
Row: 15

Legibility: ☐ sharp, tooling evident ☒ clear, but worn ☐ partially discernable ☐ not discernable

Deterioration: ☒ broken ☐ cracked ☐ losses ☐ flaking/sugaring ☐ ferrous pins
☐ brass pins ☐ delamination/detachment ☐ spalling ☐ missing fragments
☐ other:

Soiling: ☒ biological ☐ staining ☐ efflorescence ☐ other:

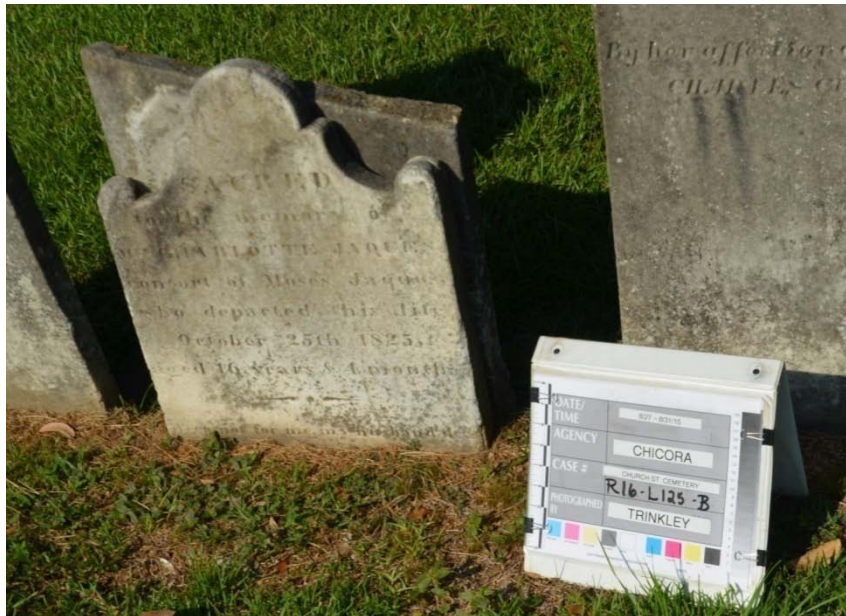
Row: 16

Position: ☒ fallen ☐ tilted ☐ unstable ☐ unattached/loose ☐ missing

Legibility: ☐ sharp, tooling evident ☒ clear, but worn ☐ partially discernable ☐ not discernable

Soiling: ☒ biological ☐ staining ☐ efflorescence ☐ other:

Position: ☒ reset/level in ground ☐ use existing base ☐ construct new base ☐ resquare
☐ new base required ☐ stabilize foundation ☐ reset with NHL ☐ reset with compound
☐ other:

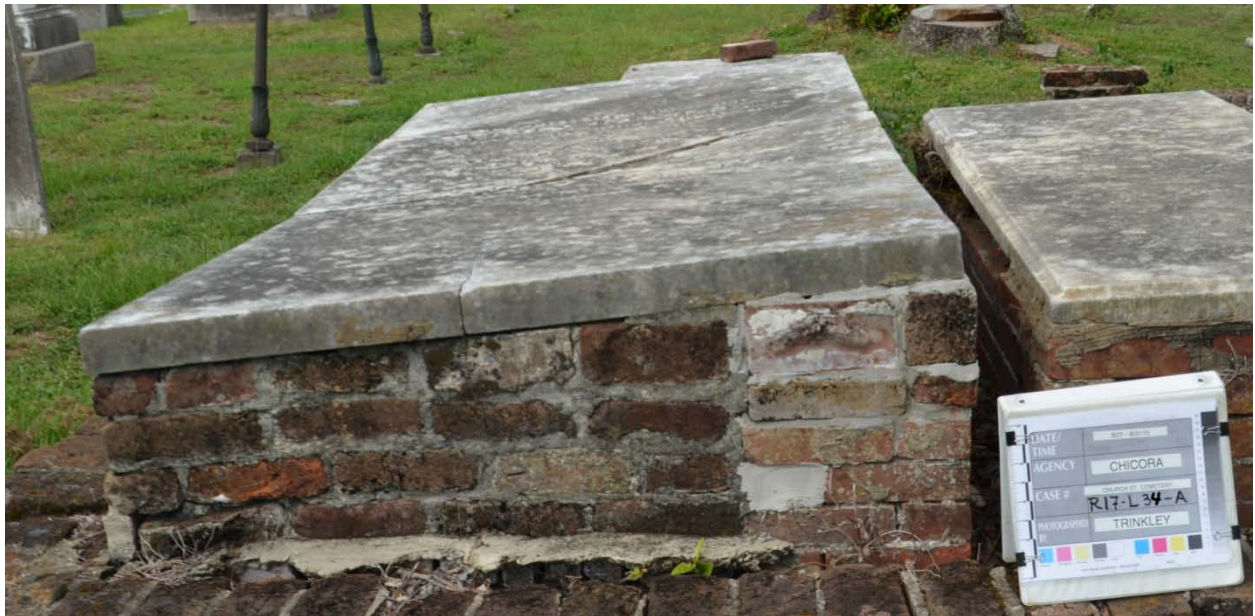
Row: 17

Position: ☐ fallen ☒ tilted ☐ unstable ☐ unattached/loose ☐ missing

Legibility: ☐ sharp, tooling evident ☐ clear, but worn ☐ partially discernable ☒ not discernable

Deterioration: ☐ broken ☐ cracked ☐ losses ☐ flaking/sugaring ☐ ferrous pins
☐ brass pins ☐ delamination/detachment ☐ spalling ☐ missing fragments
☒ other: being covered by soil and grass clippings

Soiling: ☒ biological ☐ staining ☐ efflorescence ☐ other:

Position: ☒ reset/level in ground ☐ use existing base ☒ construct new base ☐ resquare
☐ new base required ☐ stabilize foundation ☐ reset with NHL ☐ reset with compound
☐ other:

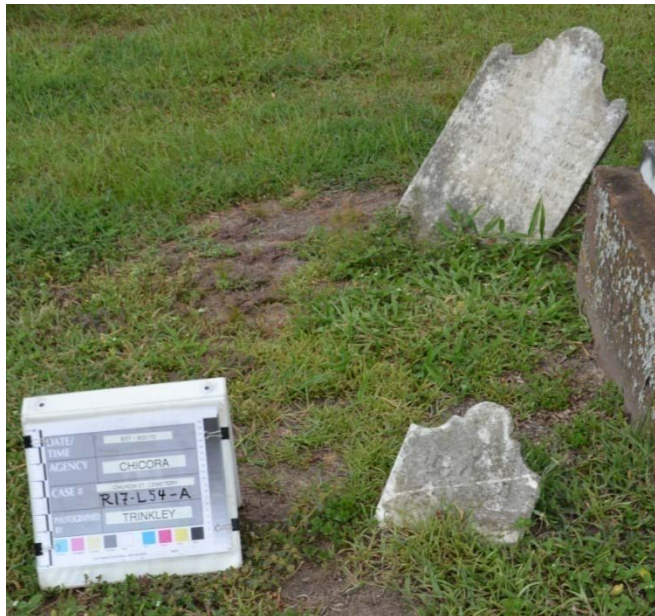
Row: 17

Position: ☒ fallen ☐ tilted ☐ unstable ☐ unattached/loose ☐ missing

Legibility: ☐ sharp, tooling evident ☒ clear, but worn ☐ partially discernable ☐ not discernable

Deterioration: ☒ broken ☐ cracked ☐ losses ☐ flaking/sugaring ☐ ferrous pins
☐ brass pins ☐ delamination/detachment ☐ spalling ☐ missing fragments
☐ other:

Soiling: ☒ biological ☐ staining ☐ efflorescence ☐ other:

Position: ☒ reset/level in ground ☐ use existing base ☒ construct new base ☐ resquare
☐ new base required ☐ stabilize foundation ☐ reset with NHL ☐ reset with compound
☐ other:

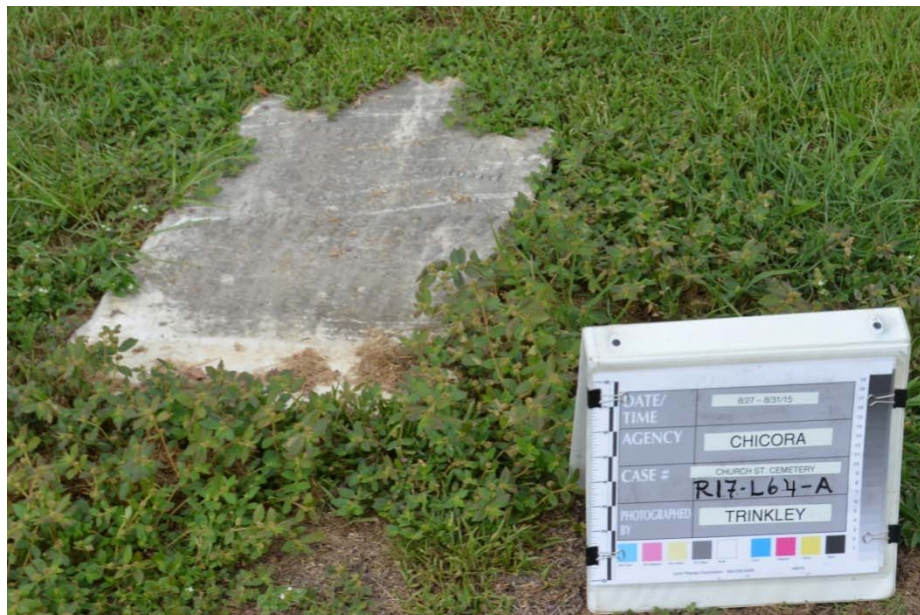
Row: 17

Position: ☐ fallen ☒ tilted ☒ unstable ☒ unattached/loose ☐ missing

Legibility: ☐ sharp, tooling evident ☐ clear, but worn ☒ partially discernable ☐ not discernable

Deterioration: ☐ broken ☐ cracked ☐ losses ☒ flaking/sugaring ☐ ferrous pins
☐ brass pins ☐ delamination/detachment ☐ spalling ☐ missing fragments
☒ other: warping; pins may be present

Soiling: ☒ biological ☐ staining ☐ efflorescence ☐ other:

Position: ☒ reset/level in ground ☒ use existing base ☐ construct new base ☐ resquare
☐ new base required ☐ stabilize foundation ☒ reset with NHL ☐ reset with compound
☐ other:

Treatment: ☐ core drill ☒ drill and pin ☐ simple adhesive repair ☐ injection grout ☐ set bricks
☐ mortar ☐ repoint ☐ infill ☐ other:

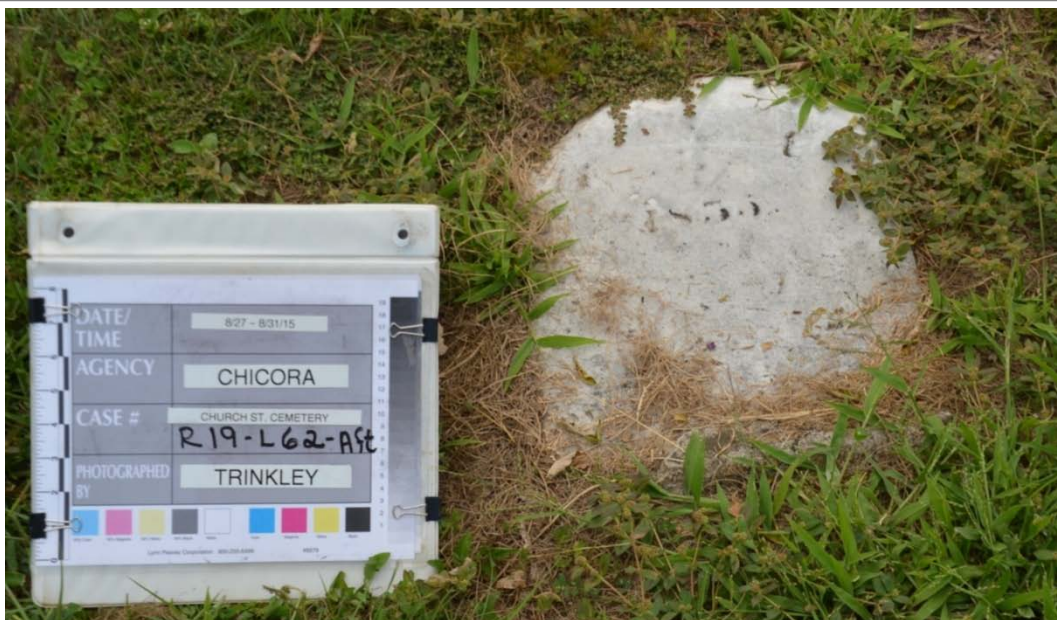
Row: 19

Position: ☒ fallen ☐ tilted ☐ unstable ☐ unattached/loose ☐ missing

Legibility: ☐ sharp, tooling evident ☒ clear, but worn ☐ partially discernable ☐ not discernable

Deterioration: ☒ broken ☐ cracked ☐ losses ☐ flaking/sugaring ☐ ferrous pins
☐ brass pins ☐ delamination/detachment ☐ spalling ☐ missing fragments
☒ other: base not observed; mower damage

Soiling: ☒ biological ☐ staining ☐ efflorescence ☐ other:

Position: ☐ reset/level in ground ☐ use existing base ☒ construct new base ☐ resquare
☐ new base required ☐ stabilize foundation ☐ reset with NHL ☐ reset with compound
☐ other:

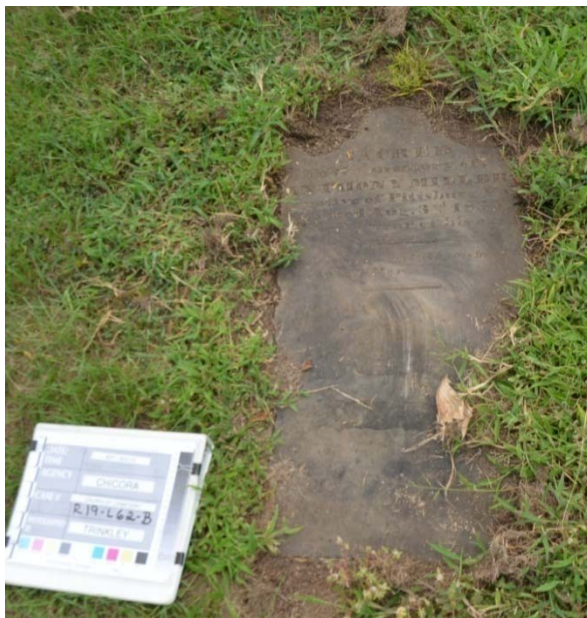
Row: 19

Position: ☒ fallen ☐ tilted ☐ unstable ☐ unattached/loose ☐ missing

Legibility: ☐ sharp, tooling evident ☒ clear, but worn ☐ partially discernable ☐ not discernable

Soiling: ☒ biological ☐ staining ☐ efflorescence ☐ other:

Position: ☐ reset/level in ground ☐ use existing base ☒ construct new base ☐ resquare
☐ new base required ☐ stabilize foundation ☐ reset with NHL ☐ reset with compound
☐ other:

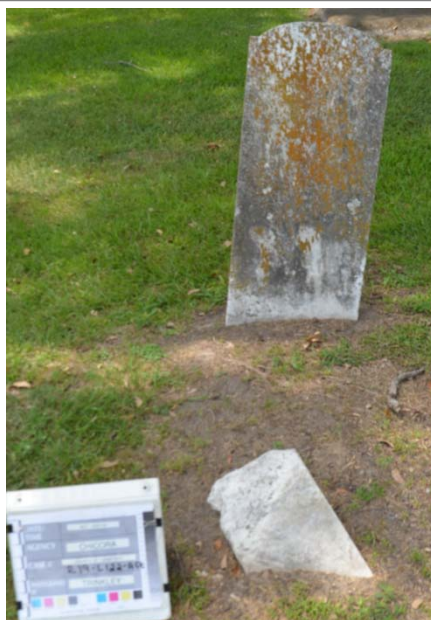
Row: 20

Position: ☒ fallen ☐ tilted ☐ unstable ☐ unattached/loose ☐ missing

Legibility: ☐ sharp, tooling evident ☒ clear, but worn ☐ partially discernable ☐ not discernable

Deterioration: ☒ broken ☐ cracked ☐ losses ☐ flaking/sugaring ☐ ferrous pins
☐ brass pins ☐ delamination/detachment ☐ spalling ☐ missing fragments
☒ other: base not seen

Soiling: ☒ biological ☐ staining ☐ efflorescence ☐ other:

Position: ☐ reset/level in ground ☐ use existing base ☒ construct new base ☐ resquare
☐ new base required ☐ stabilize foundation ☐ reset with NHL ☐ reset with compound
☐ other:

Treatment: ☐ core drill ☐ drill and pin ☒ simple adhesive repair ☐ injection grout ☐ set bricks
☐ mortar ☐ repoint ☐ infill ☐ other:

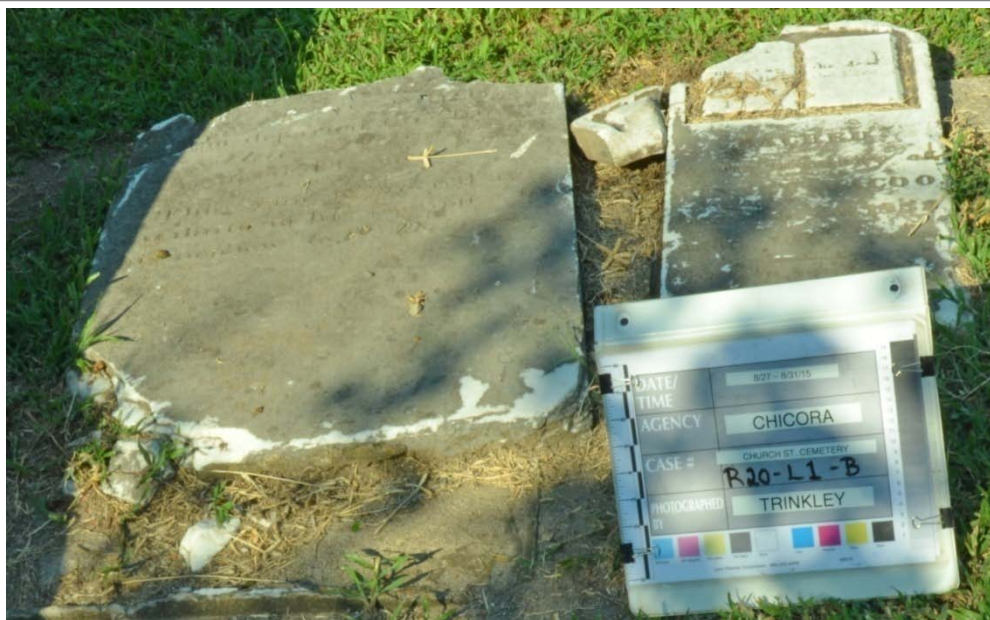
Row: 20

Soiling: ☒ biological ☐ staining ☐ efflorescence ☒ other: vegetation

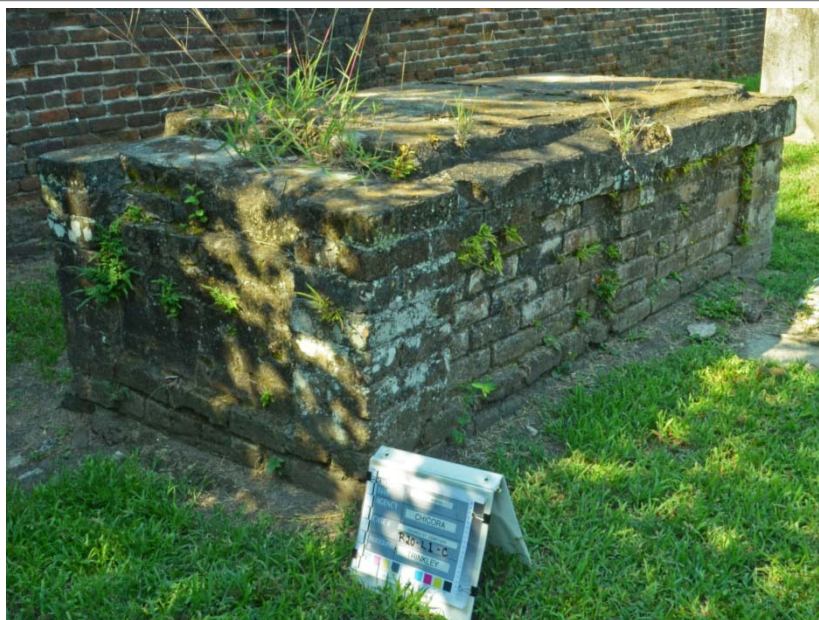
Row: 20

Position: ☐ fallen ☒ tilted ☐ unstable ☐ unattached/loose ☐ missing

Legibility: ☐ sharp, tooling evident ☐ clear, but worn ☐ partially discernable ☒ not discernable

Deterioration: ☐ broken ☐ cracked ☐ losses ☐ flaking/sugaring ☐ ferrous pins
☐ brass pins ☐ delamination/detachment ☐ spalling ☐ missing fragments
☒ other: mower damage

Soiling: ☒ biological ☐ staining ☐ efflorescence ☒ other: tire tracks

Position: ☒ reset/level in ground ☐ use existing base ☐ construct new base ☐ resquare
☐ new base required ☐ stabilize foundation ☐ reset with NHL ☐ reset with compound
☐ other:
